# July 2025 Hot Fire Summary

## BSEP Engine 2 maiden test

On the 1<sup>st</sup> of July the BSEP Engine 2 was hot fire tested at Airborne Engineering Ltd.

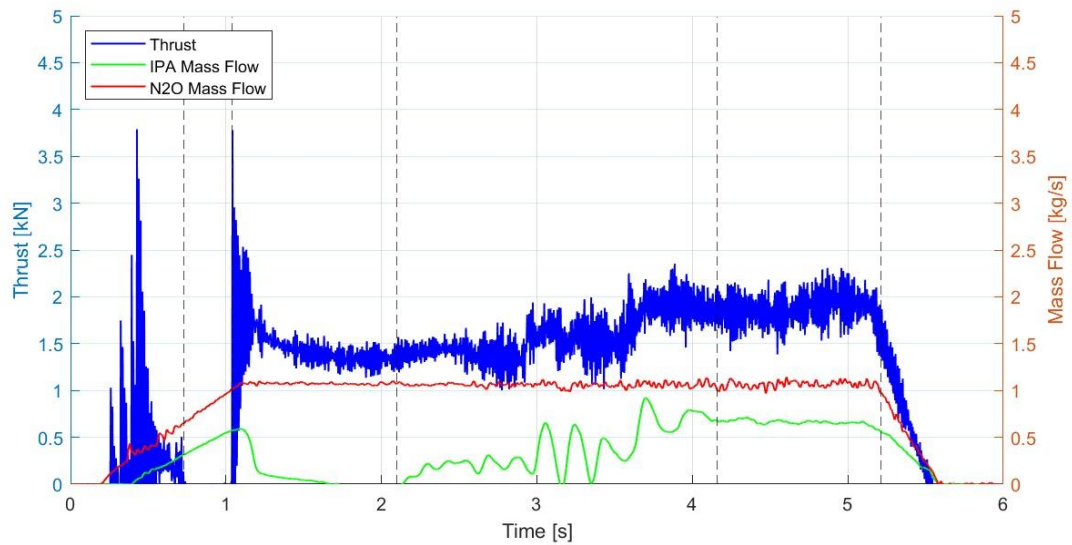
Figure 1, graph showing Thrust and mass flows against Time. The different phases of the burn can clearly be seen in the Thrust and IPA mass flow lines while the N2O remains steady but below the desired value. Each spike in the IPA mass flow line could be a channel bursting and Airborne's fuel valve compensating for it.

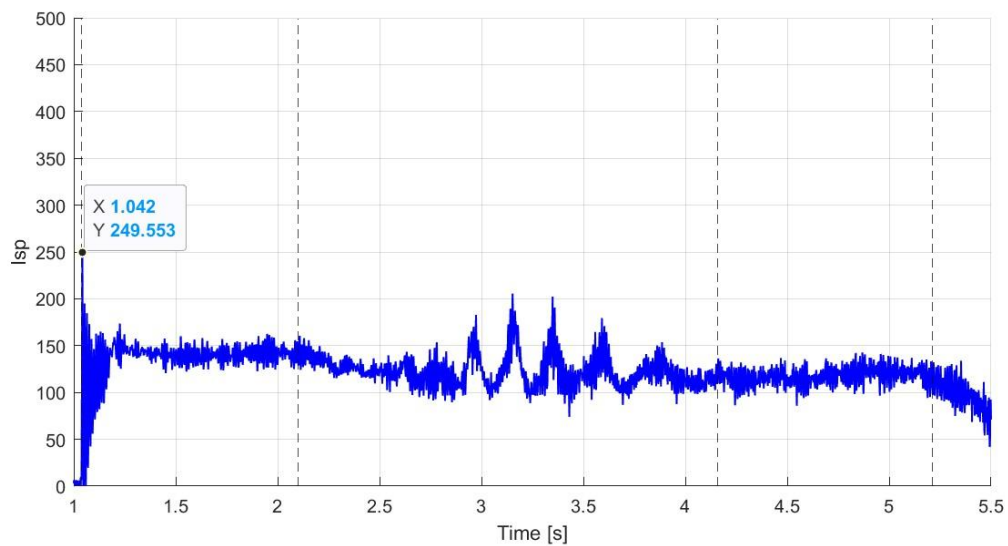
Figure 2, graph showing the Specific Impulse against Time. Clearly peaks and ~250s an gets close to 200s multiple times throughout the burn. Otherwise its really really bad so only look at the peaks thanks.

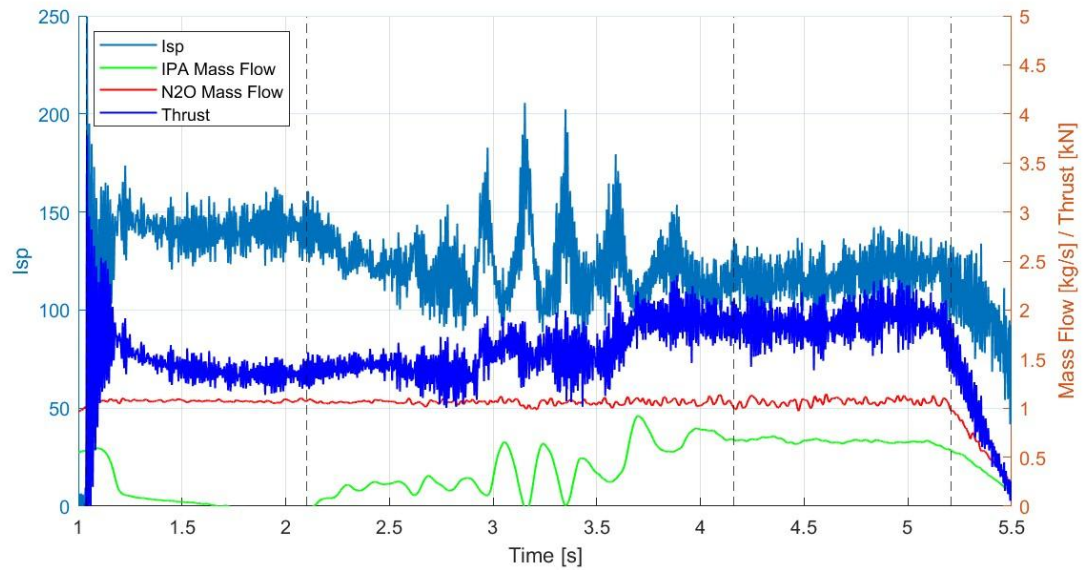
Figure 3, graph combining Figure 1 and Figure 2. Specific Impulse goes crazy when the IPA mass flow has a stroke.

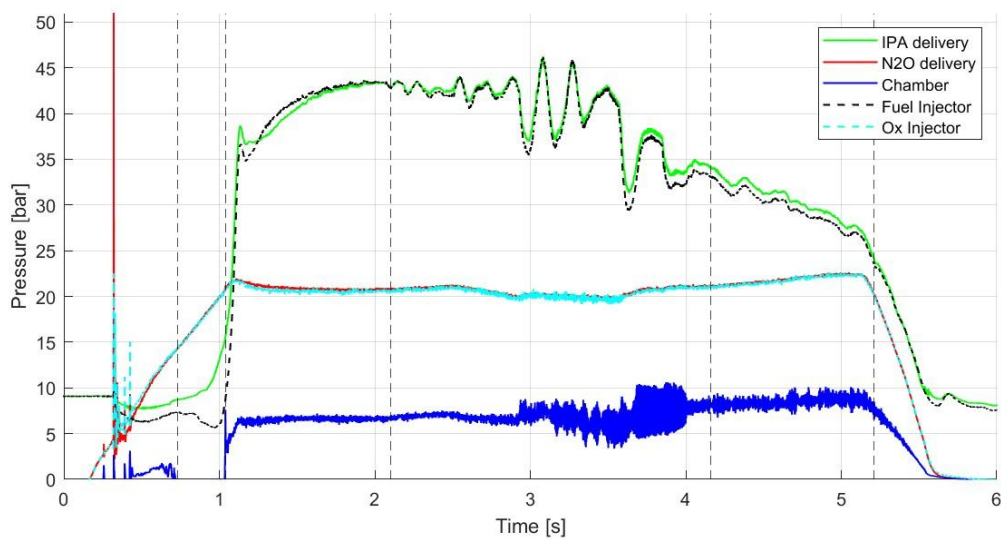
Figure 4, graph showing the pressure data. The pressures inside the injector manifolds can be seen to line up pretty much exactly with the delivery pressures. The chamber pressure remains low throughout the burn, following the pattern of beginning lower, having a stroke, then returning slightly higher. Also worth noting the IPA pressure is ~10 bar higher than expected and the chamber pressure ~10 bar lower than expected, resulting in a net 20 bar greater pressure drop on the inner wall of the chamber between the cooling channels and the combustion area.

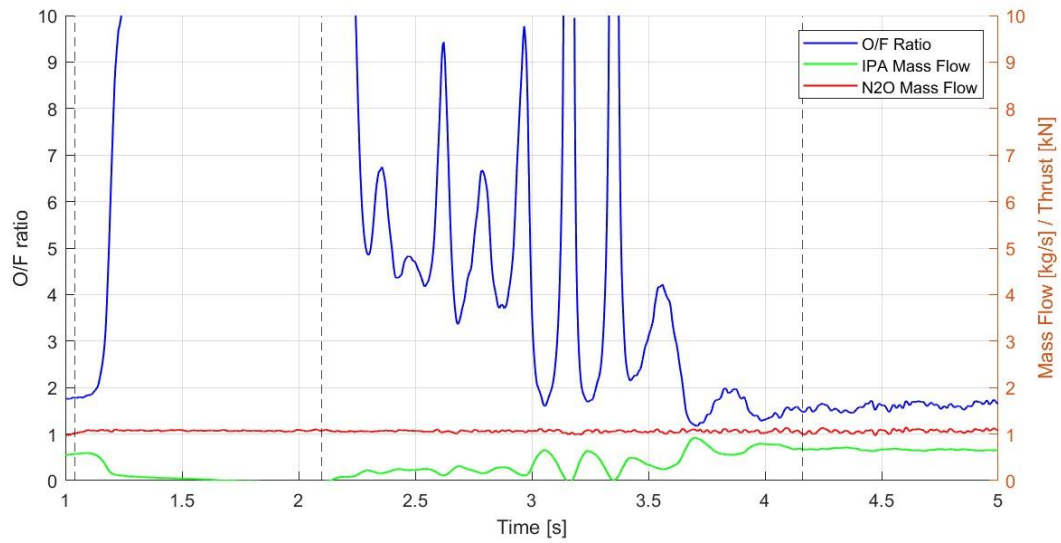
Figure 5, graph showing the mass flows and O/F ratio against Time. As expected, the O/F ratio begins extremely high, most likely abetting the chamber failure. It then swiftly proceeds to have a stroke, and stabilize below the designed ratio.

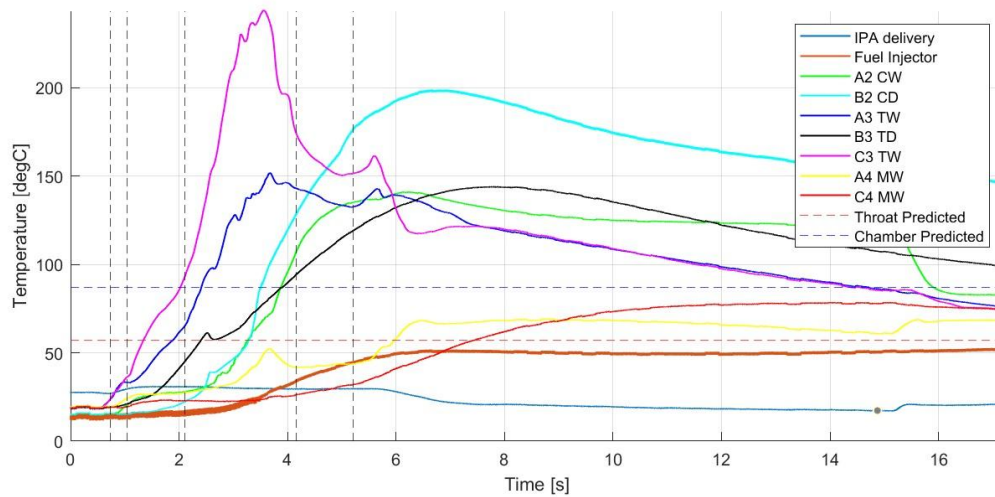
Figure 6, graph showing thermocouple data. See BSEP 2025 CDR for diagram explaining thermocouple placement. A, B, and C run across  $\frac{3}{4}$  of the chamber. 2 is on chamber wall, 3 is at throat, and 4 is in chamber manifold. B thermocouples are dry, the rest are wet. More clear thermal data of specific parts and explanations shown below.

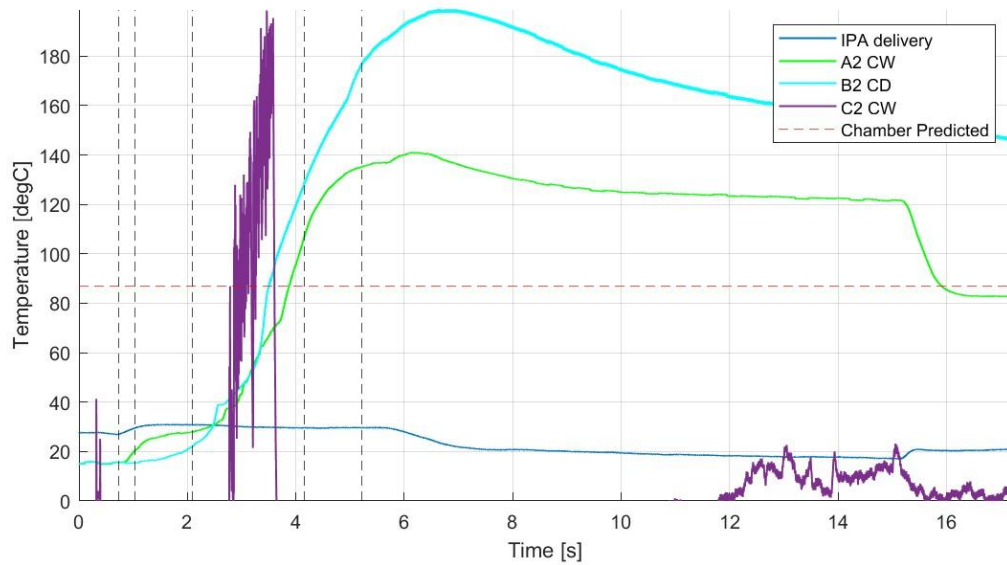
Figure 7, graph showing chamber thermocouple data. C2 will be ignored since it seems to have some sort of issue. A2 is directly reading the coolant temperature and by the end of the burn it is well above the predicted value. B2 also clearly demonstrates the Aluminium doesn't reach steady state even though it was assumed it would during a nominal burn.

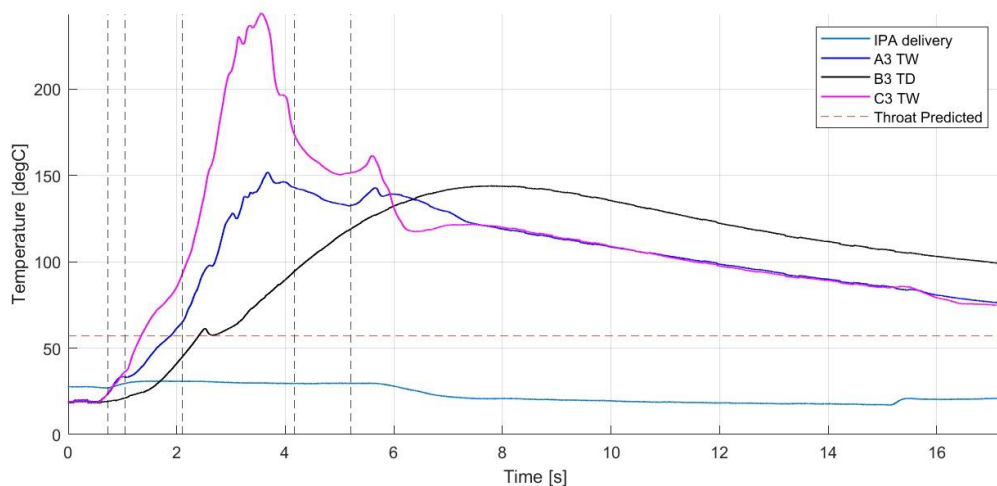
Figure 8, graph showing throat thermocouple data. It is immediately apparent that the throat coolant temperatures are higher than the chamber coolant temperatures. This is extremely disturbing since in our regen system it should always be the opposite, with more heat being added to the coolant as it moves past the throat. This further reinforces the fact that there was no coolant flow. The throat coolant temperatures during the burn also exceed the predicted value by almost 200 degrees and is almost certainly boiling. The C side also seems to be significantly hotter than the A side, which can also be seen in the damage itself. They do line up after the burn though as things cool down which is a good sign of their accuracy.

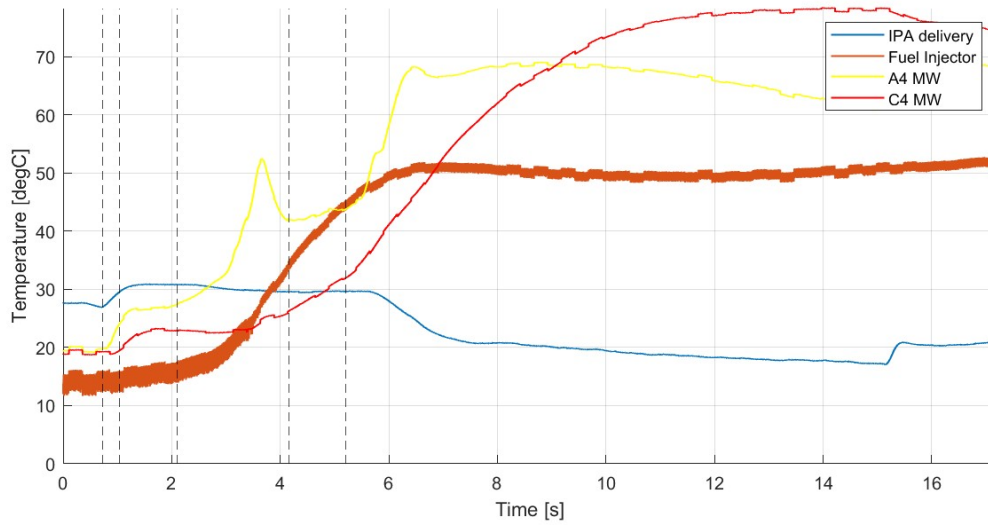
Figure 9, graph showing the chamber fuel manifold and injector fuel manifold thermocouple data. A4 and C4 should be identical but A4 seems to have some anomalies so no conclusions can be drawn from that.

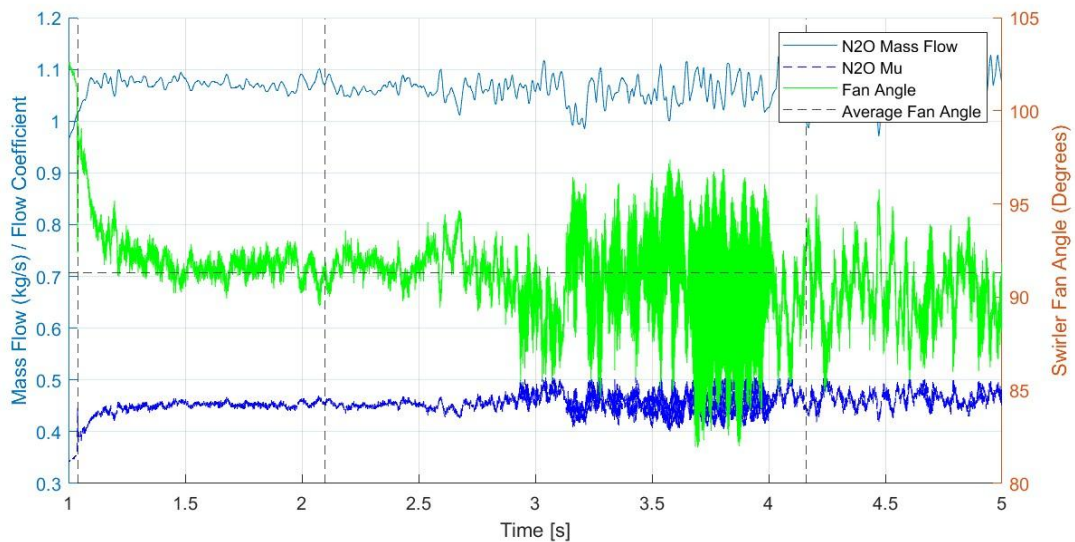
Figure 10, graph showing Injector fan angle against time. For a coaxial swirl Injector, one of the main performance factors is the fan angle (angle of swirled spray cone exiting swirler elements). Since IPA mass flow was unreliable, only the N2O flow was analysed. Originally, the fan angle was designed to be 90 degrees and initial 3d printed elements validated the design. However, due to manufacturing constraints, the angle was changed to 110 degrees and the efficacy of this new angle was only semi-validated during hasty 3d print tests. After processing the data, the average fan angle calculated was 93 degrees. This number is none-conclusive since N2O's 2-phase characteristics lead to a large error bar and the fuel wasn't accounted for. Nevertheless, if the fan angle was truly close to the calculated 93 degrees under these extremely arduous conditions, it's a good step in validating the coaxial swirl design.

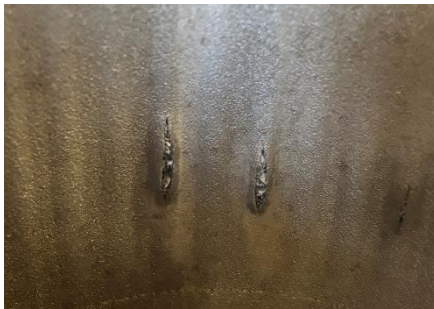
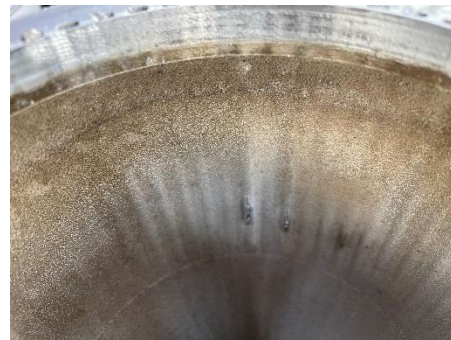
This lack of fuel mass flow is due to swarf, that was inside the regen cooling channels and chamber manifold, being forced into the injector and clogging it. Surprisingly, the flame doesn't die out, only weakening, until T+2.10 where we believe burnthrough occurred.

Clear bursts can be seen in the chamber. There are 5 major ones and a lot more smaller cracks. Almost every other channel has bulged significantly. This all happened at the same elevation inside the chamber. At first we thought this was where the oxidizer fan from the swirlers were hitting the wall, but the angle doesn't match. The "popping" of the channels is most likely a combination of the elevated inner wall temperature (due to lack of cooling and higher O/F ratio) degrading the strength of the Aluminum (see CP-1 strength graphs in BSEP 2025 CDR) and the increased pressure delta across the inner wall.

The major bursts are clustered and line up exactly where the swirl elements are located. So do the largest streaks of melting at the throat.

*Figure 11 & 12, Swarf can be seen trying to escape through the burst channels*

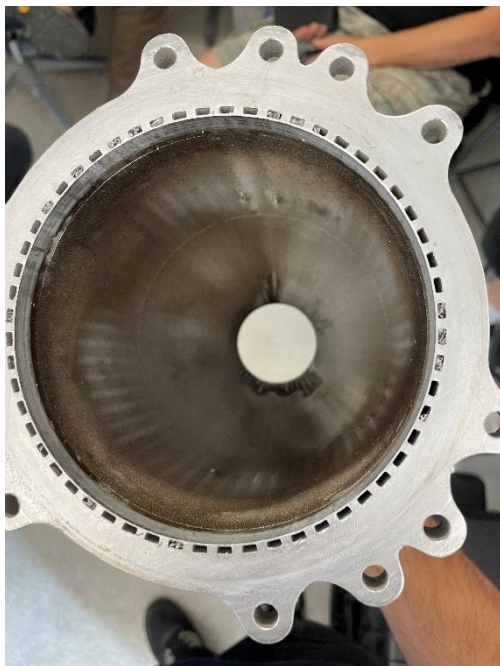
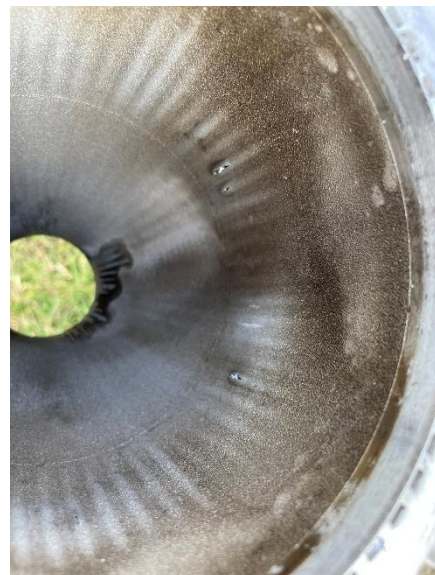
The throat is clearly melted due to the lack of cooling and high temperatures. Thin cracks and holes also appear throughout. Also noticeably no PDMS deposition is observed.

*Figure 13 & 14, Channels are clearly filled with swarf. Popping and bursts clearly visible as well as throat melt streaks.*

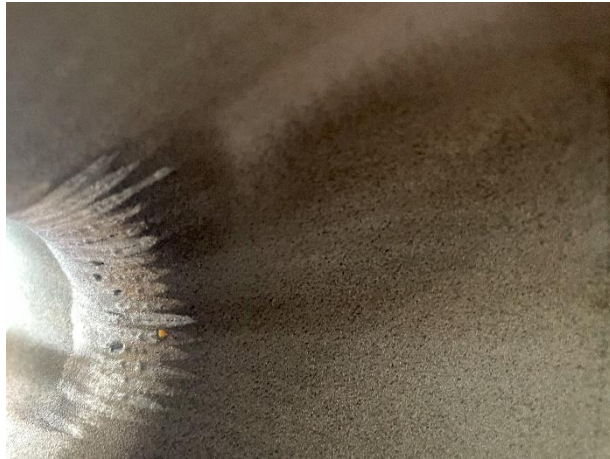
*Figure 15, Close-up on throat.*

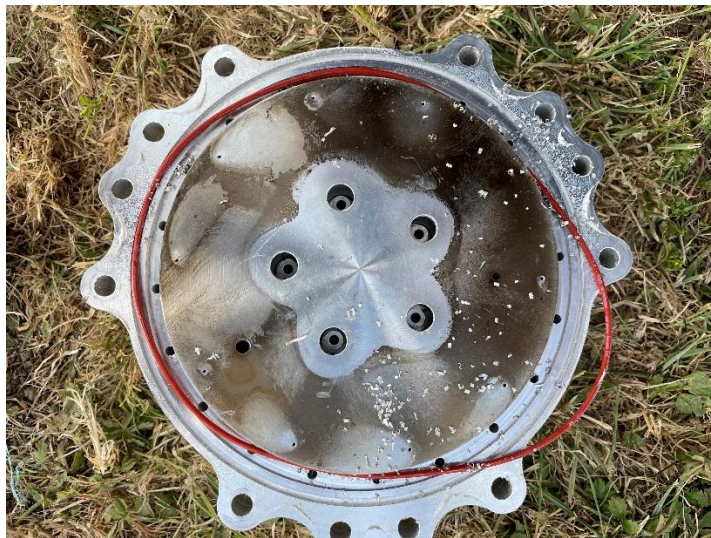
Injector damage was much less significant. Lots of swarf was uncovered during removal, some O-rings were damaged, and some holes were blocked by swarf. After thorough cleaning it should be reusable.

We believe the swarf was introduced during chamber post-machining when the baseplate was CNCed off. It was not caught during low-pressure water flows since the water just flowed around the swarf instead of pushing it all out.

*Figure 16, Injector plate immediately after it was taken off of the chamber. Swarf everywhere.*

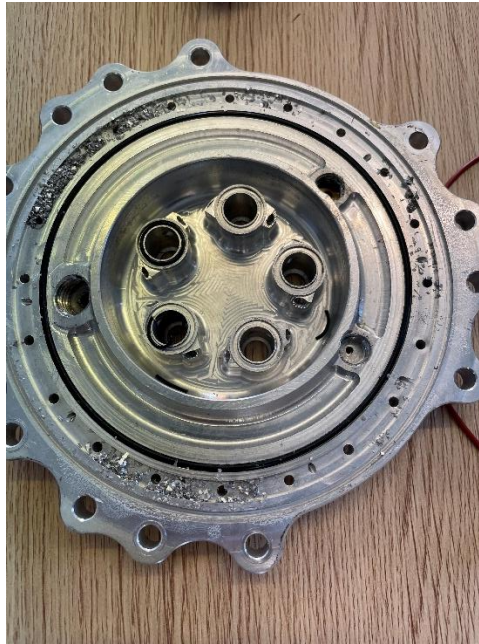
*Figure 17, inside Injector. Swarf clearly visible in the fuel collection manifold. Swirl element O-rings broken and missing.*

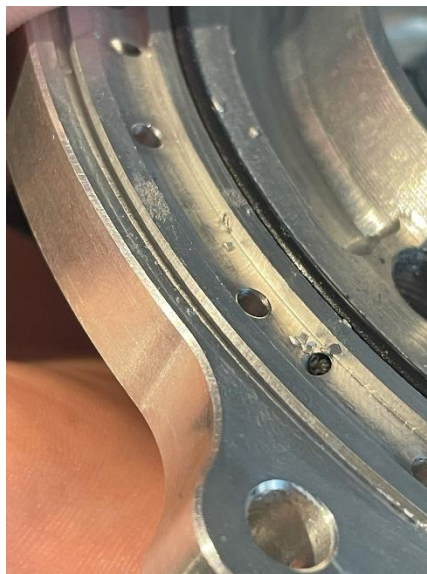
Since no fuel was flowing, nothing was cooling the chamber. The film cooling holes were completely blocked by the swarf so it effectively didn't exist. The PDMS fuel additive can't deposit if no fuel is flowing, so it effectively didn't exist. The regenerative cooling was blocked so we believe the coolant was boiling and stagnant which means it couldn't absorb heat from the inner wall, so it effectively didn't exist. All this combined with the fact that it was burning extremely ox rich makes it extremely unsurprising that the chamber failed.

*Figure 18, close-up of film cooling hole. Completely blocked by swarf.*

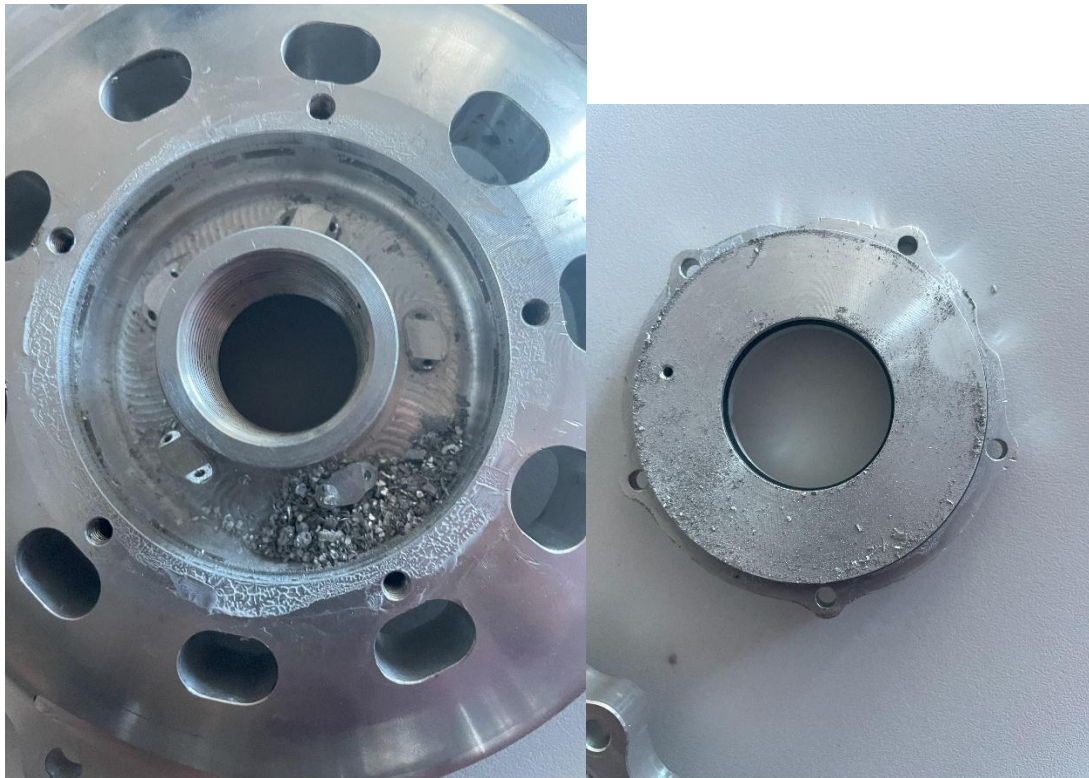
Figure 18 & 19, Injector fuel cap and fuel manifold after removal. Huge amounts of swarf deposited inside.
