# July 2025 Hot Fire Summary

## BSEP Engine 2 maiden test

On the 1<sup>st</sup> of July the BSEP Engine 2 was hot fire tested at Airborne Engineering Ltd.

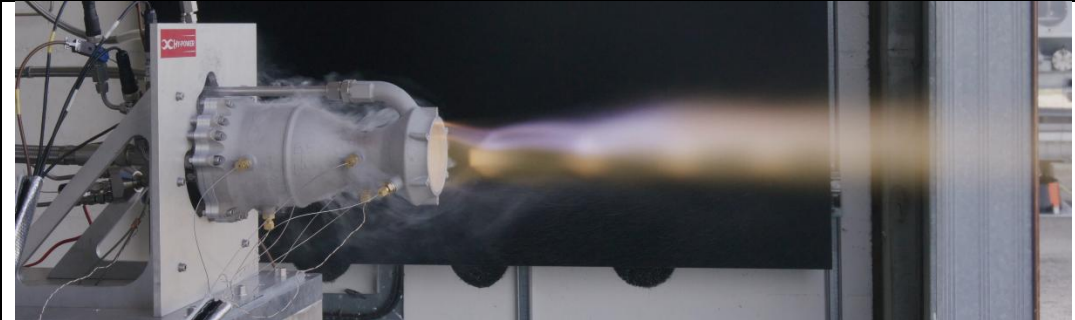
| | 2.12 |

This lack of fuel mass flow is due to swarf, that was inside the regen cooling channels and chamber manifold, being forced into the injector and clogging it. Surprisingly, the flame doesn't die out, only weakening, until T+2.10 where we believe burnthrough occurred.

Since no fuel was flowing, nothing was cooling the chamber. The film cooling holes were completely blocked by the swarf so it effectively didn't exist. The PDMS fuel additive can't deposit if no fuel is flowing, so it effectively didn't exist. The regenerative cooling was blocked so we believe the coolant was boiling and stagnant which means it couldn't absorb heat from the inner wall, so it effectively didn't exist. All this combined with the fact that it was burning extremely ox rich makes it extremely unsurprising that the chamber failed.

At T+2.12, the plume begins to turn purple and the IPA mass flow rate begins to increase. This is where the first channel burst, followed by a few more, completely changing the colour of the plume. At this point, Airborne's fuel valve has a stroke trying to keep up with the rapid sudden change in IPA mass flow, leading to weirdness throughout all the data and an unstable burn.
